Structural and Geomorphic Characteristics of Landslides at Coyote Mountain, Anza-Borrego Desert State Park, California

MICHAEL W. HART

ABSTRACT

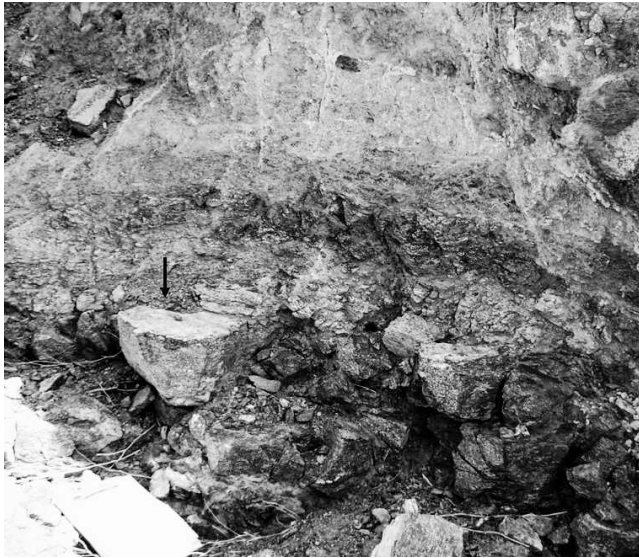
Figure 4. Basal shear zone of the westernmost landslide, Peg Leg Smith complex. See Point A, Figure 3 for location of photograph.

The westernmost landslide is well-exposed along an old mining road that traverses the central portion of the slide mass and along two deeply incised gullies near its southern flank (Figure 3). The landslide extends from an elevation of approximately 1,000 ft (305 m) at the head to an elevation of 600 ft (183 m) along the valley floor, where the base of the slide is buried by alluvium and talus. The precise location of the southern flank of the landslide is not known because of insufficient outcrop. Although the base of the landslide is buried beneath alluvium and talus at its northern flank, the base of the landslide is well-exposed near its southern flank in the walls of a gully just south of the mining road, approximately 30 ft (9 m) above the valley floor (Figure 4).

An exposure of the slide base occurs in a narrow gully approximately 30 ft (9 m) in elevation above the valley floor (Figure 4). Here, the basal rupture zone consists of matrix-rich breccia that dips sub-horizontally and parallel to the foliation in the underlying gneiss. A true slip surface typical of translational landslides is not present at this location, and the light brown, fine-grained material at the base of the slide mass has the consistency of fine silty sand with only slight plasticity. The elevated position of the basal shear above the valley floor indicates that the slide has a very irregular slip-surface geometry, since several hundred feet to the north, the basal shear zone lies much lower in elevation where it is buried by alluvium.

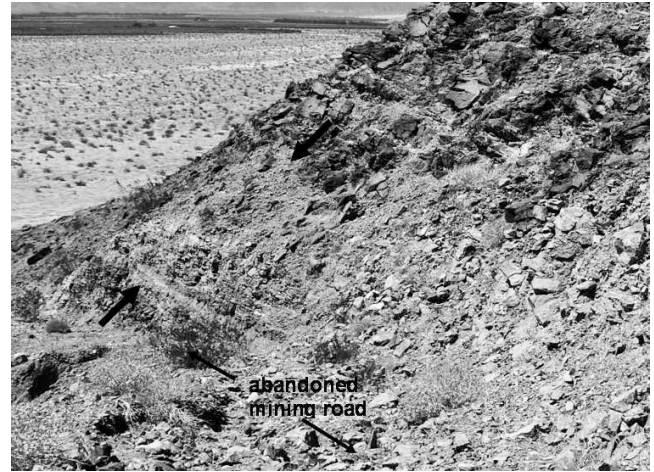
Figure 5. View to northwest along old mining road of crude stratigraphy in the western landslide, Peg Leg Smith landslide complex. Arrows delineate matrix-rich breccia and thin pulverized zone at base.

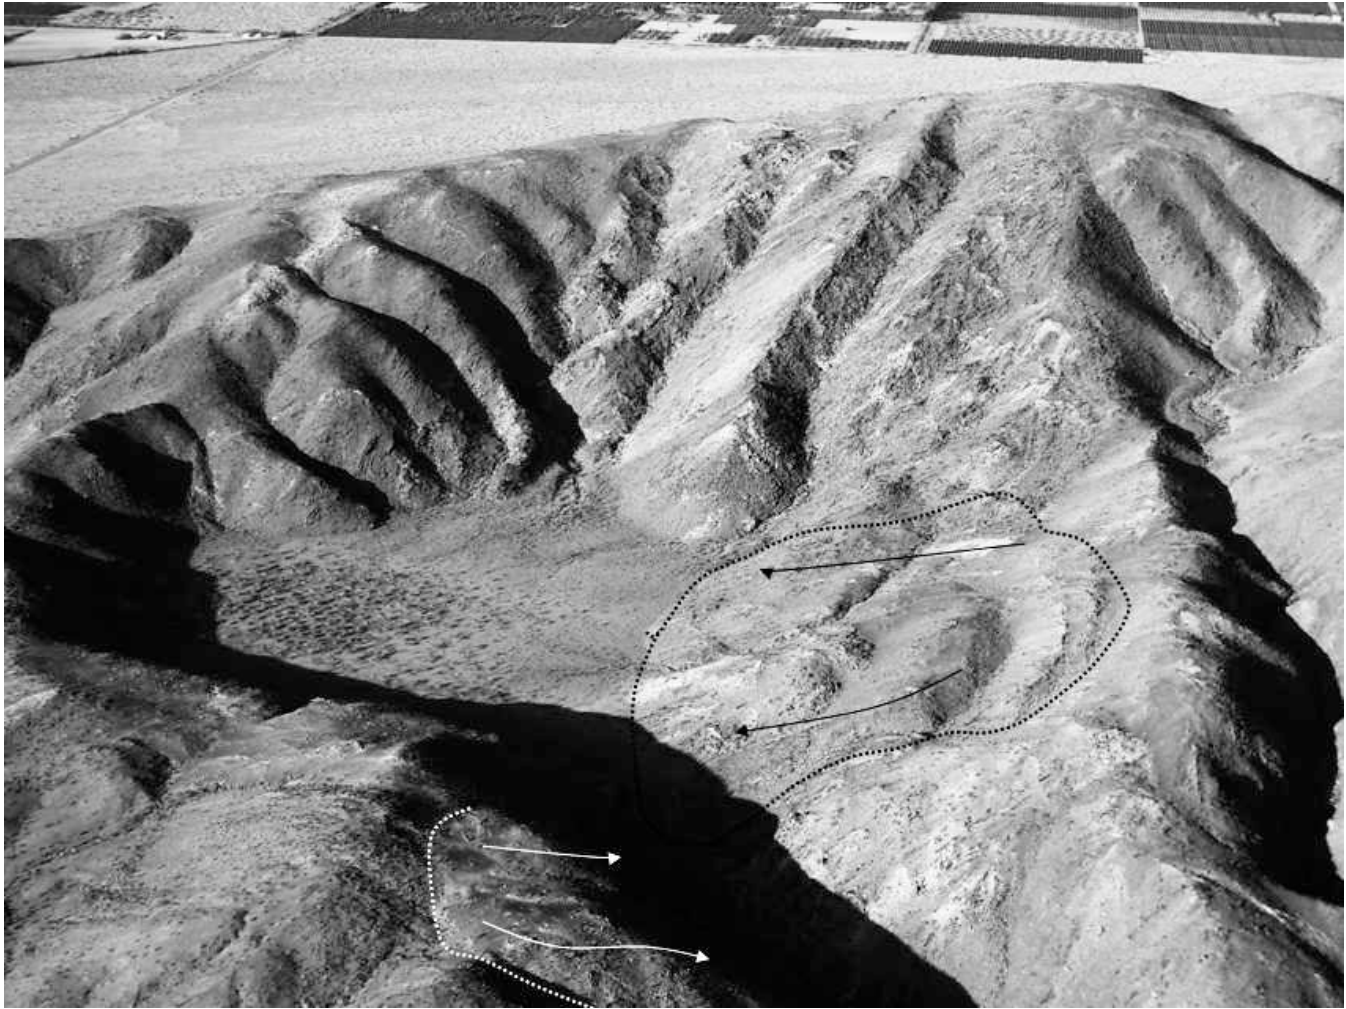
Figure 8. Landslide dam north of the Peg Leg Smith landslide complex. See Figure 6 for location. Trapped alluvium in valley is estimated to be 150 ft (47 m) thick.

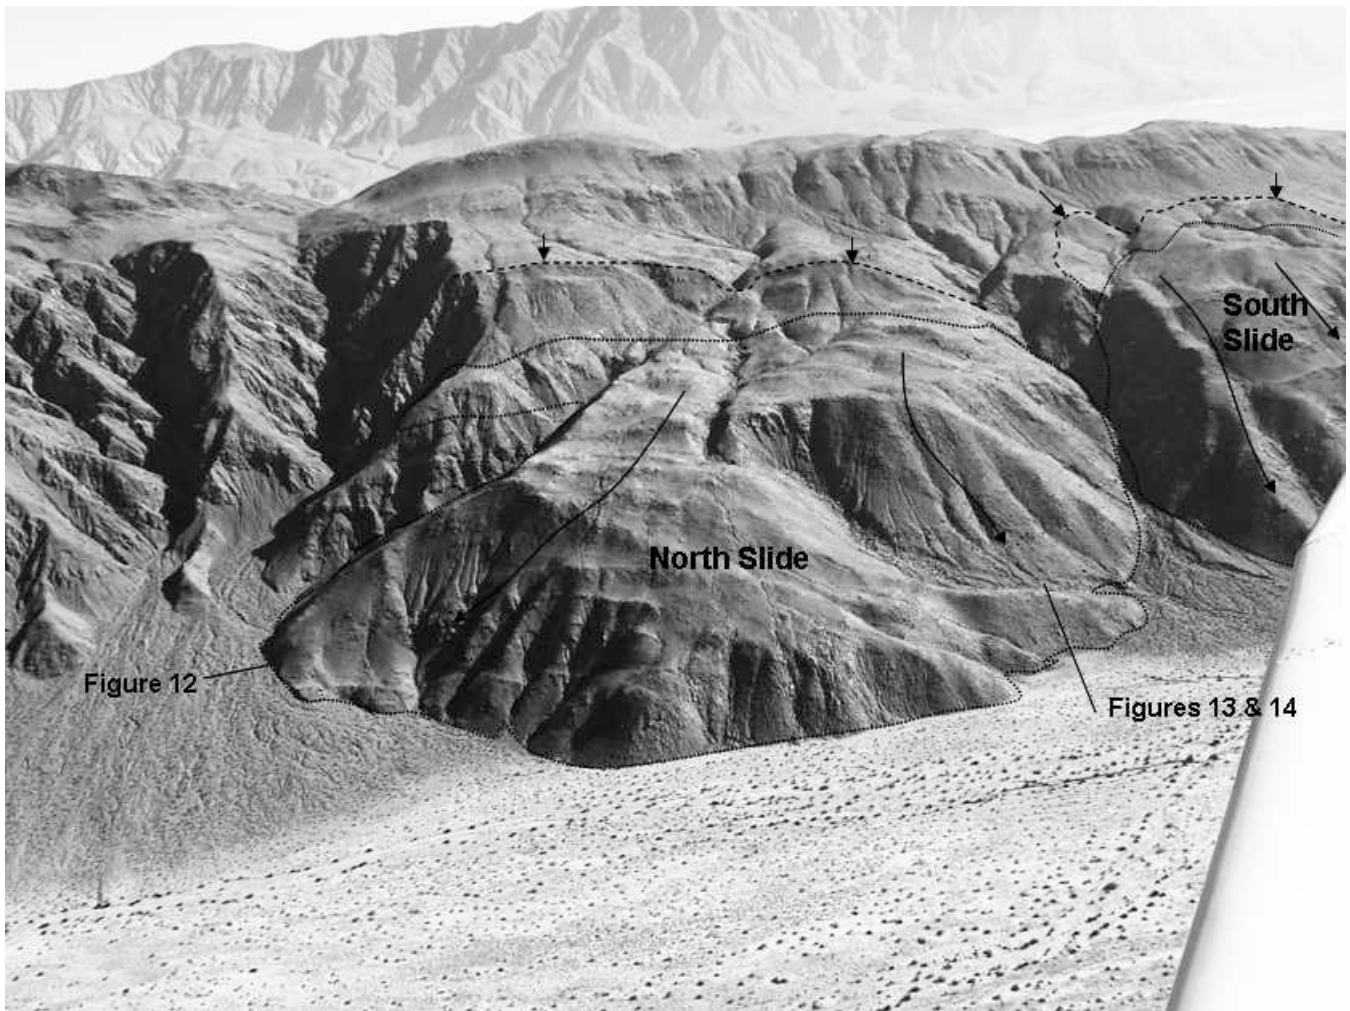
Figure 10. Heavily eroded north slide and portion of south slide, Coyote Peak landslides, showing location of Figures 12, 13, and 14. Short arrows point to top of headscarps. View is to east from Borrego Valley.

The relatively subtle headscarps of the Coyote Peak landslides occur to the west of a more obvious, longer, and much higher scarp (Figure 10), which at first glance appears to be a headscarp of a larger landslide. A closer evaluation, however, reveals that the scarp continues further south than the landslide terrain and eventually terminates in an area removed from any evidence of landsliding. Although it is tempting to attribute the origin of the scarp to landsliding, outcrops of in-place metamorphic rocks in the deep canyon at the northern terminus indicate an erosional or perhaps fault origin. Shallow rockfall debris estimated to be approximately 20 to 30 ft (6 to 9 m) thick occurs on the bench below the scarp. Evidence for landsliding consists of the subtle head-

scarps (Figures 10 and 11), the presence of matrix-rich landslide debris, and low- to high-angle shear zones exposed in several deeply incised canyons.

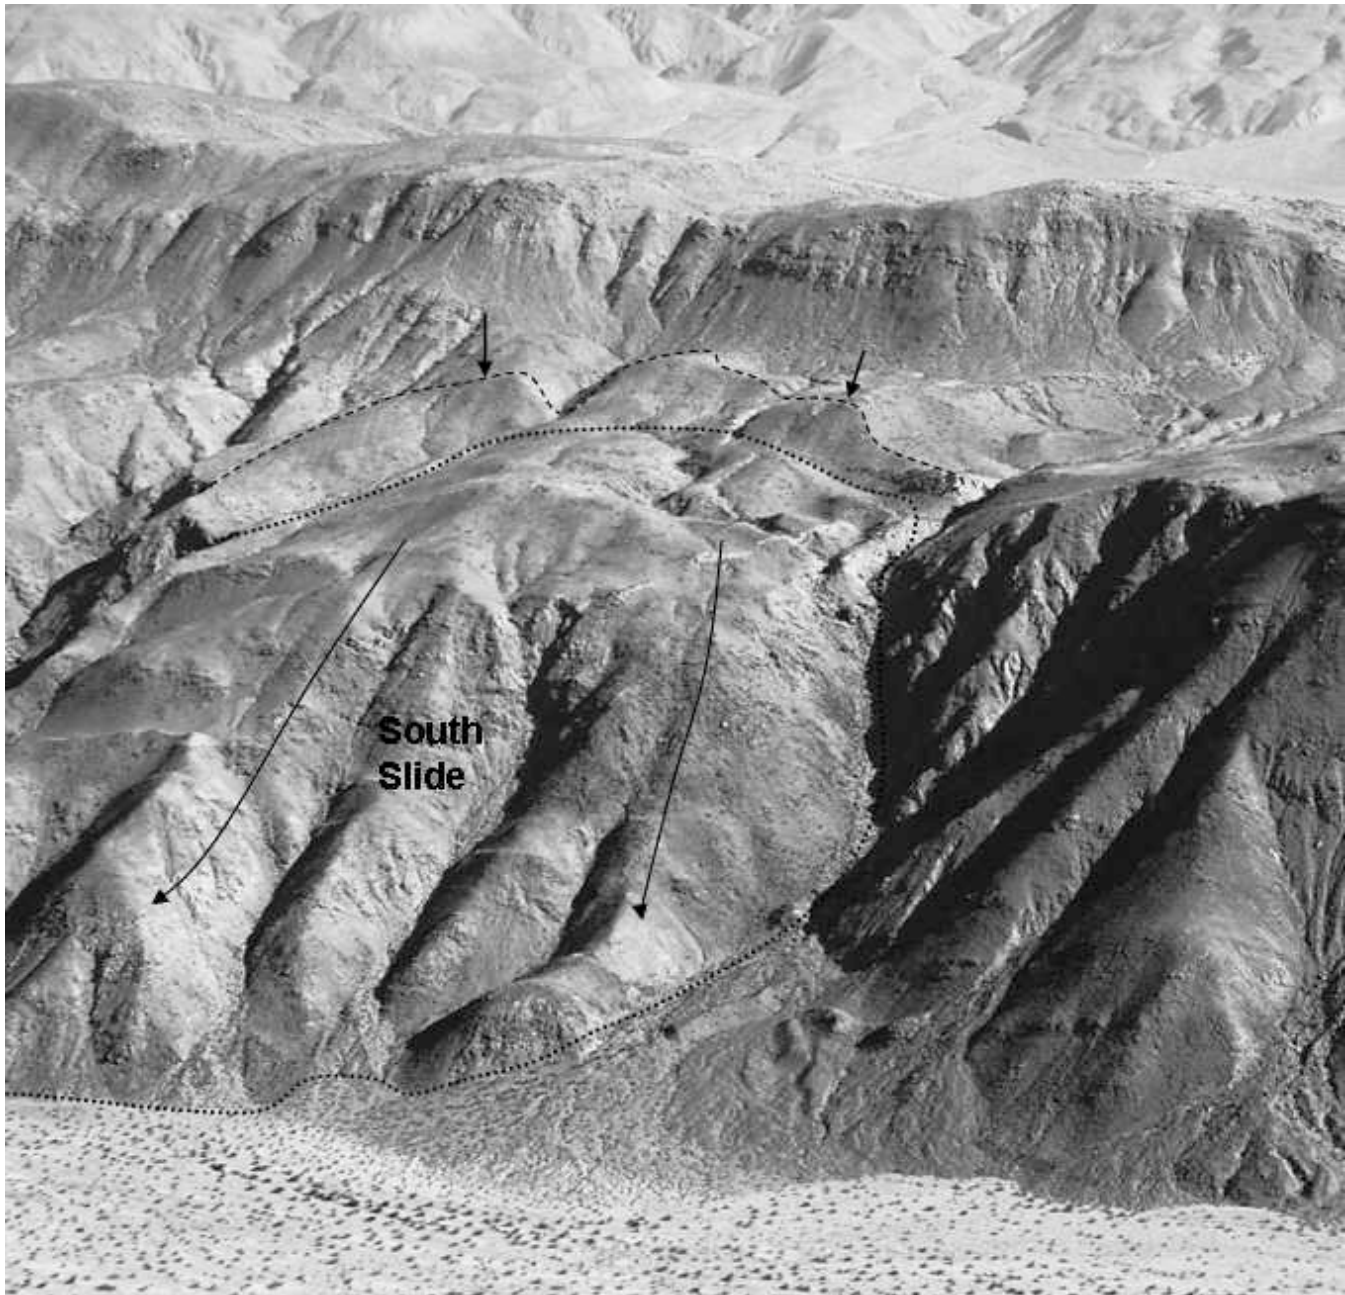
Figure 11. Coyote Peak landslides. View is to east of the south slide.

The southernmost of the two landslides has a highly eroded arcuate headscarp that varies from 80 to 160 ft (24 to 50 m) high (Figure 11). Smaller, secondary scarps are located at the head of the slide, and there is a low uphill-facing scarp near the toe. Structural evidence of landsliding is present in several small canyons along the toe of the slide, where thin zones of shearing and breccia can be observed. The basal shear zone of this slide is buried beneath the

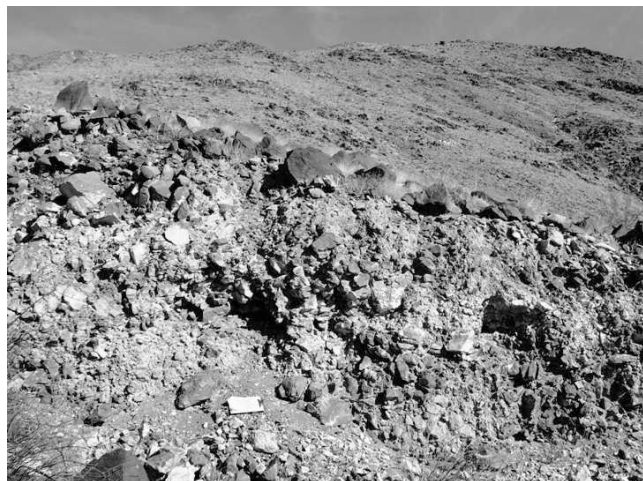
Figure 12. Coyote Peak landslides. Landslide debris can be seen at the toe of the north slide. Clipboard at base of stream cut is shown for scale.

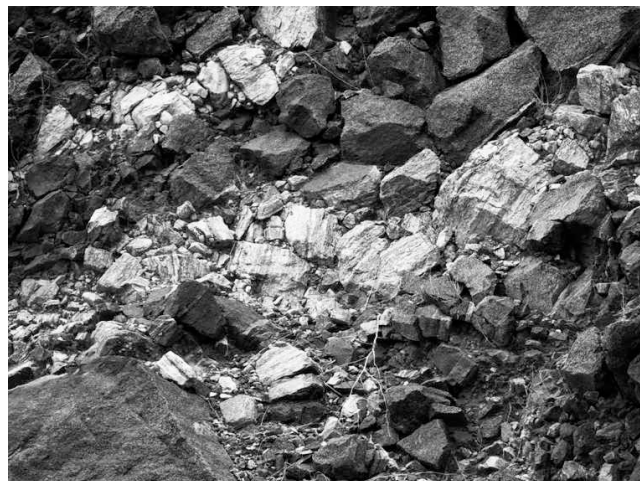
Figure 14. Rotated clasts of white dike material near toe of north slide. Largest clasts have maximum dimension of approximately 1 ft (0.3 m).

described as white breccia zones consisting of clasts rotated along the planes of the dikes during shearing and translation (Figures 13 and 14).

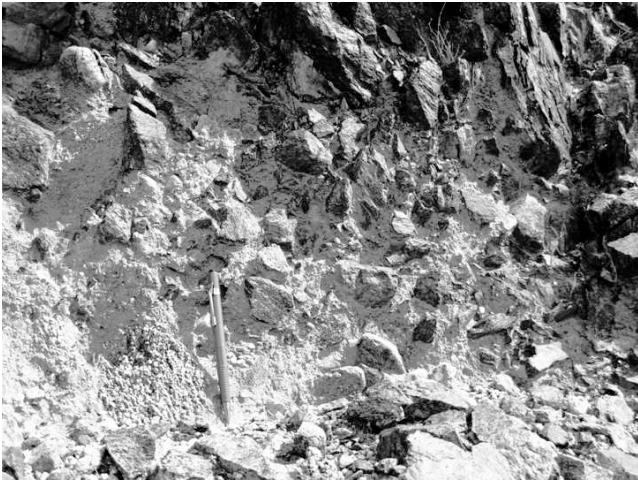
Figure 19. Basal rupture zone exposed at the toe of the southern Alcoholic Pass landslide. Note how matrix-supported angular breccia clasts grade upward to clast-supported breccia.
