The Otay Mesa Lateral Spread, a Late Tertiary Mega-Landslide in Metropolitan San Diego County, CA

Key Terms: *Landslides, Urban Geology, Engineering Geology, Otay Mesa Lateral Spread, San Diego County*

ABSTRACT

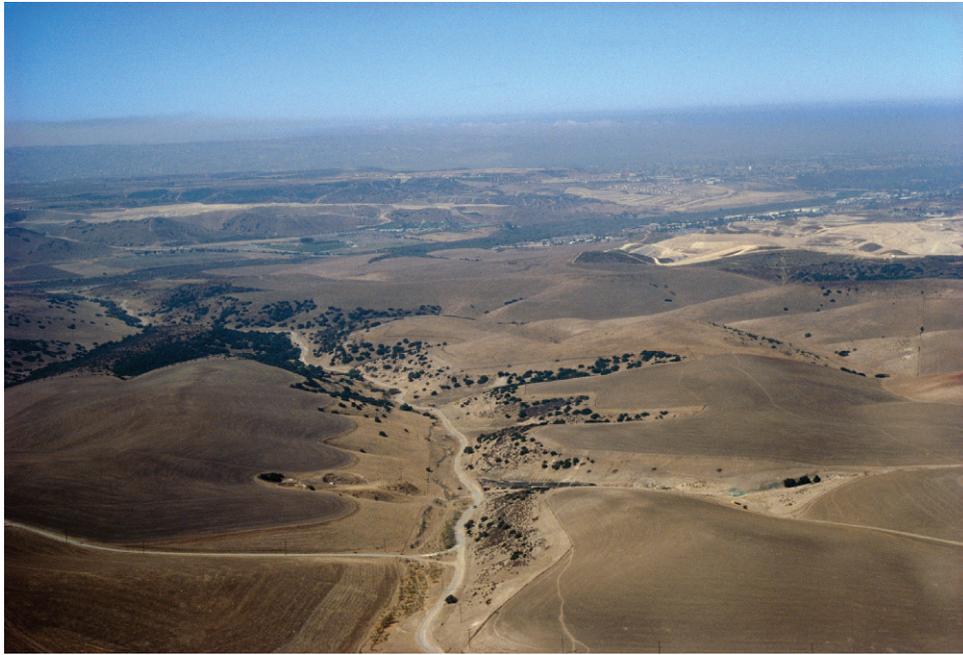
Figure 2. Photograph of the Otay Mesa–Chula Vista area showing the gently rolling terrain prior to development. View is to the southwest along Salt Creek toward Otay Valley. Note the lack of outcrops.

The natural topography in southwestern San Diego County consists primarily of gently rolling hills dissected by numerous westward-draining canyons (Figure 2). Alluvial deposits within the canyons in many areas range from 6.1 m to 15 m thick, and a shallow mantle of colluvium covers the hillsides. There are typically few naturally occurring outcrops. Prior to development, knowledge of the geology was based on isolated road-cut exposures, particularly Chester Grade (Locality 4, Figure 1), and exposures in open-pit bentonite mines south of the Otay River. Beginning in the late 1980s and early 1990s, residential developments began moving farther eastward and southward from Interstate 805. These developments were generally limited to the ridge or mesa tops and canyon bottoms, and, as such, earth moving was relatively minimal. More recent grading, beginning in the mid- to late 1990s, began to provide better geologic exposures as residential and commercial development advanced into areas previously utilized for agriculture and ranch land.

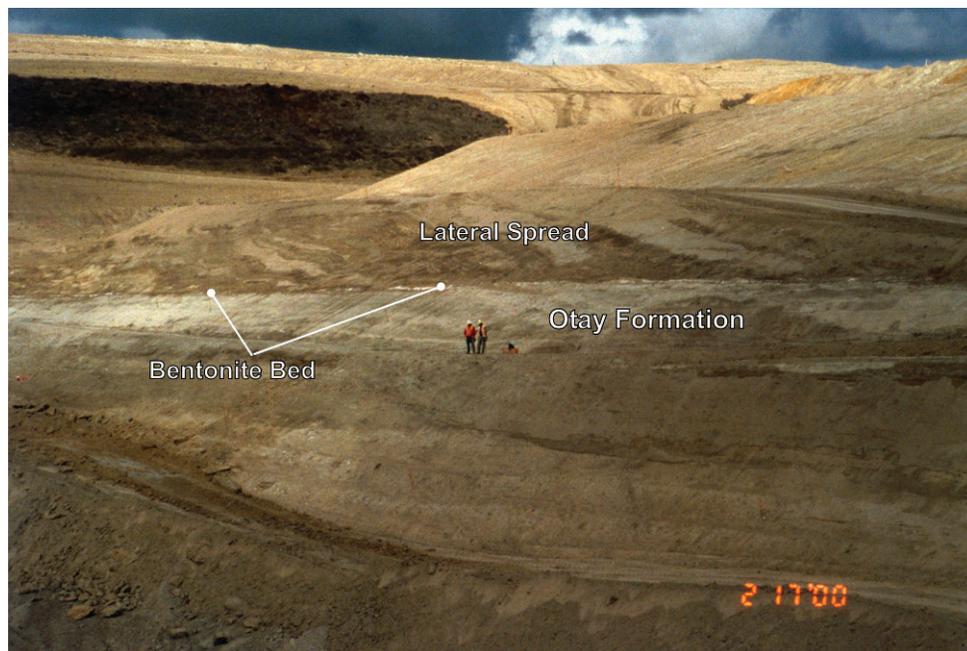
Figure 7. Photograph of the contact between the intact Otay Formation and the Otay Mesa Lateral Spread, taken at the Otay Landfill (Locality 7). The flat-lying bentonite bed is clearly visible.

of Poggi Canyon (Figures 4, 5, and 6) and at the Otay Landfill property (Figure 7). At these locations, the landslide debris consists of steeply-tilted, coherent blocks, separated by steeply-dipping shear zones. In many places, the displaced material is characterized

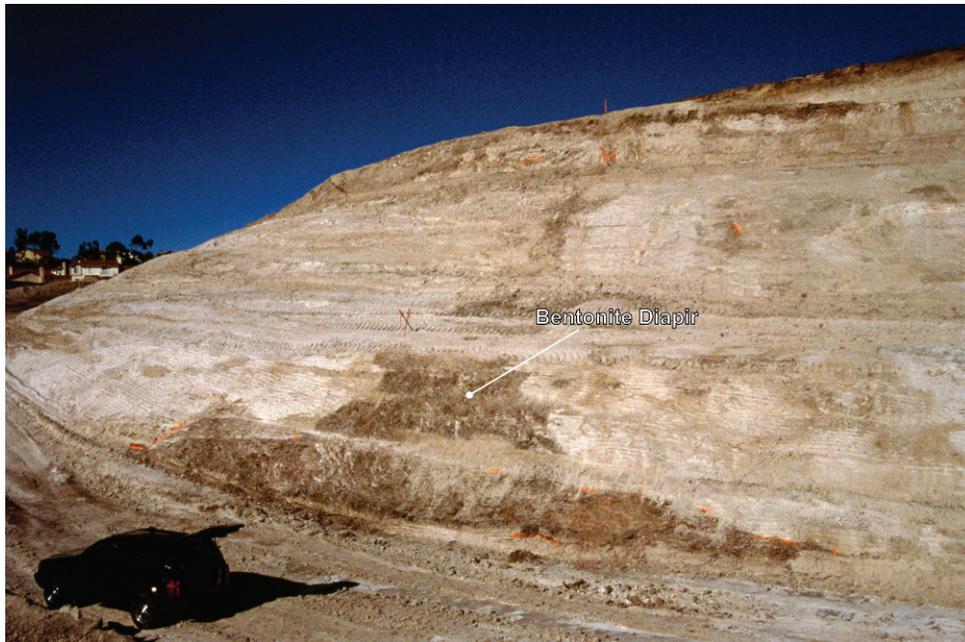
Figure 8. Photograph of a large diapor of bentonite.

by flame structures, composed of bentonite, extending upward from the base of the landslide over 5.5 m into the slide mass (Figure 8). The entire mass moved on the lower bentonite layer at elevation 110 m in the vicinity of Paseo Ranchero.

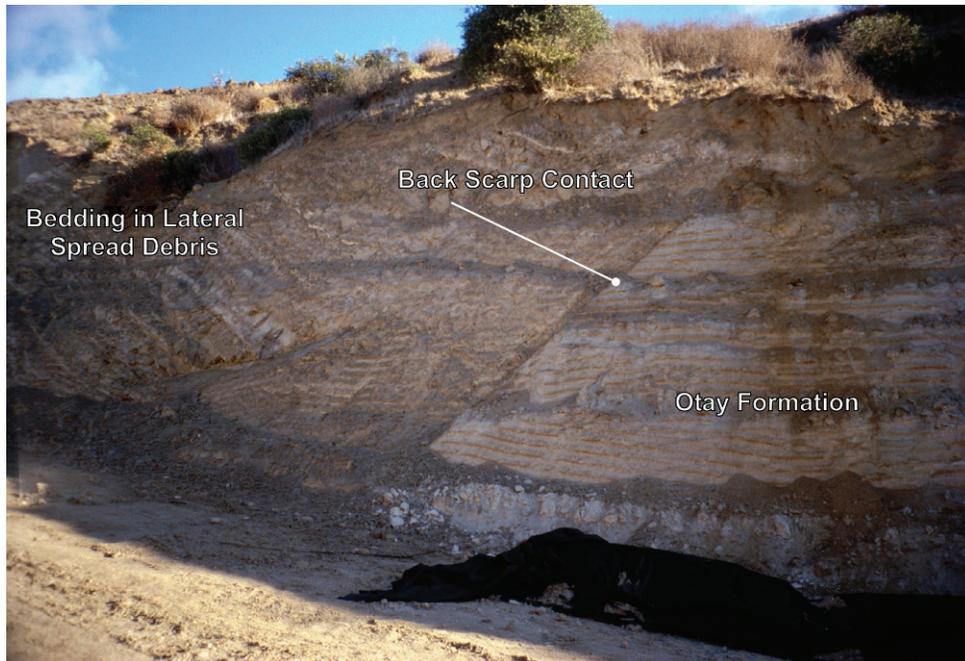
Figure 9. Photograph of the back-scarp contact on the north side of Poggi Canyon, looking northeast. Note the massive to flat-lying bedding of the intact Otay Formation, and the southeast-dipping bedding of the Otay Mesa Lateral Spread.

sheared mixtures of claystone, sandstone, and bentonite (Figures 5 and 6). Several blocks near the head of the lateral spread exhibit steeply dipping, backward-rotated bedding (Figure 9). In all cases, the blocks are moderately well lithified or moderately cemented with calcium carbonate. Many of the blocks contain irregularly shaped bodies of bentonite ranging from 1 to 3 m in length. The bentonite

The head of the Otay Mesa Lateral Spread is marked by a clear, steeply dipping, fault-like shear that separates highly deformed and broken debris on the west from massive, undisturbed Otay Formation sandstone on the east (Figures 4 and 9). Immediately adjacent to the headscarp, the graben debris shows highly chaotic bedding with no discernible preferred orientation. However, to the west of the chaotic debris, the graben consists of a 50 m zone of nearly uniformly back-tilted (dipping 30 to 50 degrees to the east and striking within a few degrees of north-south) clay beds. The bedding observed in the graben is composed of alternating green, red, and white claystone and a thin bentonite bed that correlates well with the “Christmas Beds” found approximately 60 m higher in the Otay Formation section. This band of “uniformly disturbed beds” can be traced over 1.6 km in a north-south direction. The presence of this band of “uniformly disturbed bedding” suggests that, prior to the failure, the source material was dense enough not to liquefy, and that the mode of failure was uniform over a large area.

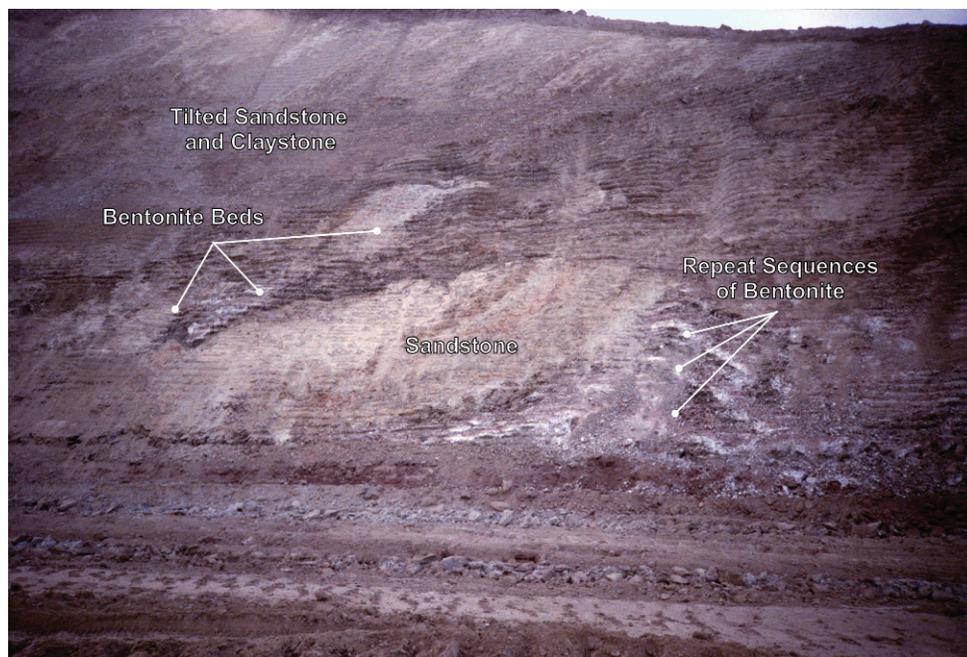
Figure 11. Photograph of a buttress back-cut slope on the south side of Telegraph Canyon Road just east of Paseo Ranchero. The bentonite has been squeezed up into the debris and folded into a complex recumbent structure.

diapir-like intrusive bodies or occurs as stretched and tapered fragments (Figure 11).

The basal rupture clearly occurred on or within a thick continuous bentonite clay bed that ranges in thickness from 10 cm to 2 m (Figure 11). The upper portion of the basal rupture zone commonly exhibits soft-sediment or plastic deformation in the form of dike-like intrusive bodies into the overlying debris, or complex recumbent drag folds (Figure 11). Residual

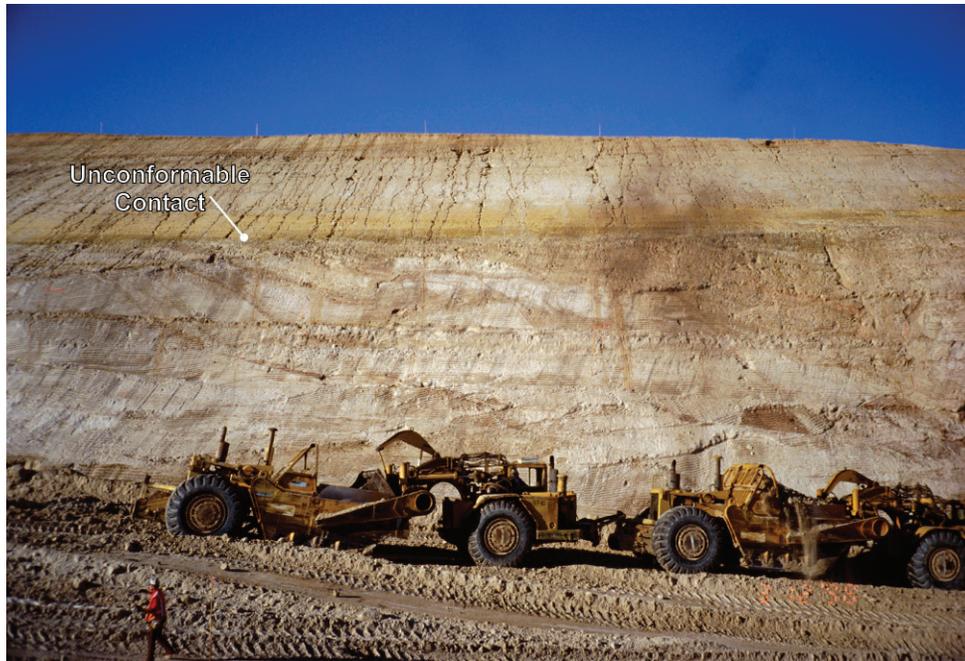
Figure 12. Photograph of a buttress back-cut slope along the west side of Paseo Ranchero. The chaotic bedding in the Otay Mesa Lateral Spread is clearly truncated by the San Diego Formation.

Diego Formation. The unconformity between the Oligocene Otay Formation beds, from which the Otay Mesa Lateral Spread is derived, and the Pliocene San Diego Formation clearly separates the undisturbed San Diego Formation from the underlying Otay Mesa Lateral Spread debris (Figure 12). This relationship indicates a minimum late Pliocene–early Pleistocene age for the Otay Mesa Lateral Spread. The presence of the “Christmas Beds” in the graben indicates that failure must have occurred after the deposition of at least 60 m of Otay Formation above the basal bentonite. The lack of soft-sediment deformation in the Otay Mesa Lateral Spread debris and the fact that the sandstone and claystone blocks within the landslide were, for the most part, brittlely deformed, indicate that the Otay Formation had to have been somewhat lithified prior to initiation of the lateral spread. Finally, at least 60 m of erosion or faulting must have occurred at the toe of the landslide prior to the failure to expose the basal bentonite and destabilize the mass. Figure 14 depicts a likely sequence of events that would produce the observed geology.

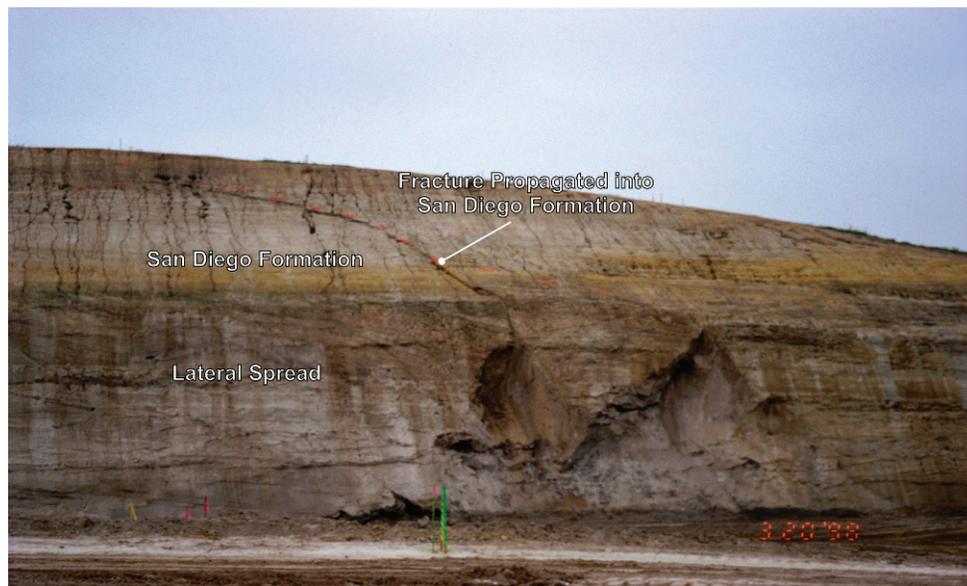
Figure 14. Photograph of a construction failure in progress. The fracture propagated up into the San Diego Formation from the Otay Mesa Lateral Spread, requiring large amounts of additional earthwork and stabilization efforts.

typical method of evaluating slope stability for future grading is to drill large-diameter (1 m) borings in areas where the slopes will be cut. The geologist enters the boring and logs it for potentially unstable geologic structure. If the boring is not drilled sufficiently deeply to intercept the basal rupture surface, or is not located in a shear zone separating the intact blocks within the debris, the potentially adverse structure will not be recognized (Figure 14).
